Manhole Inspection Summary

Manhole # S15II1027MH

Insp Date: **3/12/07 11:18 AM**

Location Address: **4250 GREENSPRING AVE**

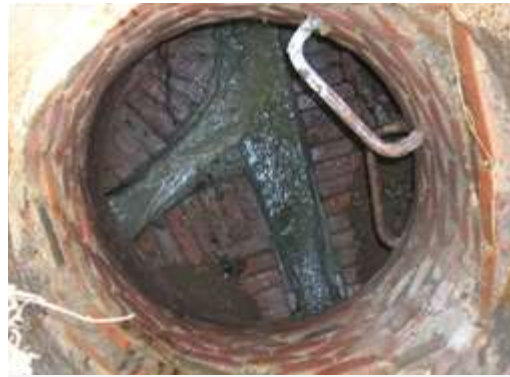
Top View

Bench debris. Corroded steps.

Evidence of surcharge

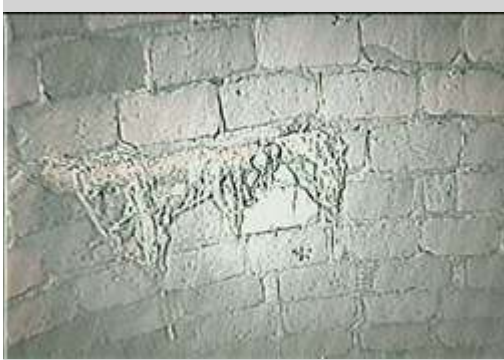
Defect

Frame leaks. Adjustment deterioration, root intrusion and infiltration.

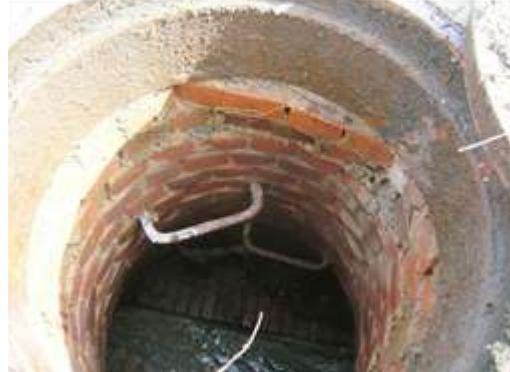
Defect

Frame leaks. Adjustment deterioration, root intrusion and infiltration - other side.

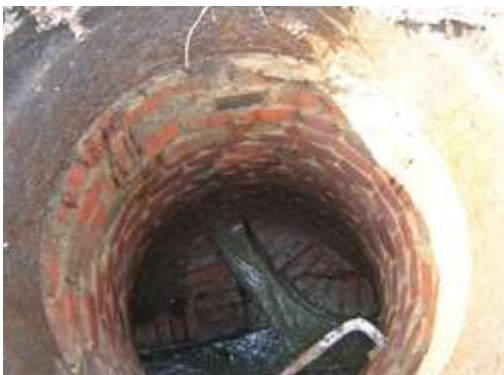
Defect

Corbel deterioration, root intrusion and infiltration.

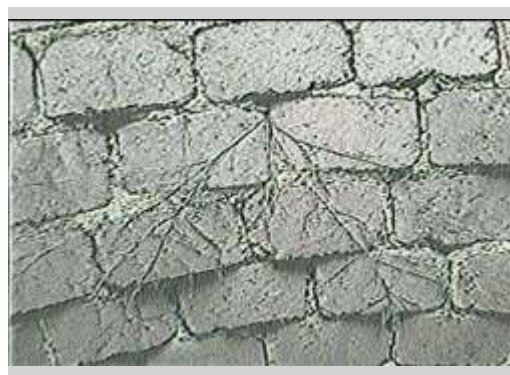
Defect

Barrel deterioration, root intrusion and infiltration.

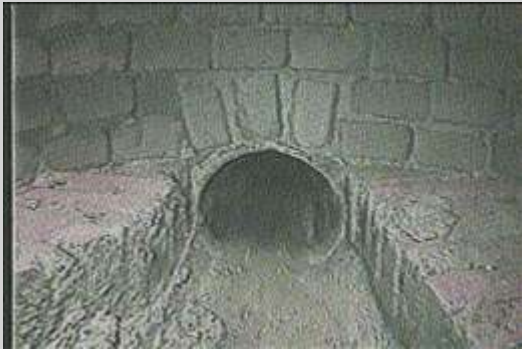
8 in. Circular Gravity Sewer Pipe Out @ 12 O'Clock

Deposits: ☐ None ☐ Mud ☐ Sludge ☐ Debris ☒ Grease

Silt Depth: **0** (in.) Deposits Extent: **Light**

Infiltration: **Evidence** Pipe Seal Cond: **Unknown**

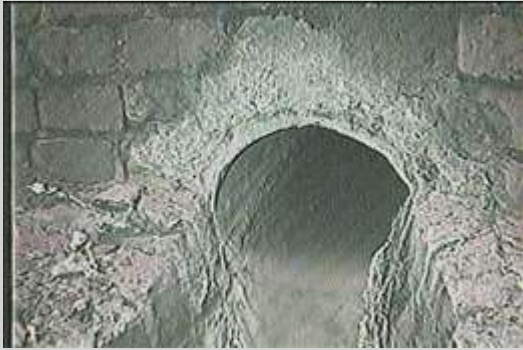
8 in. Circular Gravity Sewer

Barrel deterioration and infiltration. Channel root intrusion and infiltration. Bench deterioration.

Infiltration: **Evidence** Pipe Seal Cond: **Roots**
